# EFFECTS OF ROAD DISTANCE AND PROTECTIVE MEASURES ON DEICING NaCl DEPOSITION AND SOIL SOLUTION CHEMISTRY IN PLANTED MEDIAN STRIPS

by Lars Bo Pedersen<sup>1</sup>, Thomas B. Randrup<sup>2</sup>, and Morten Ingerslev<sup>3</sup>

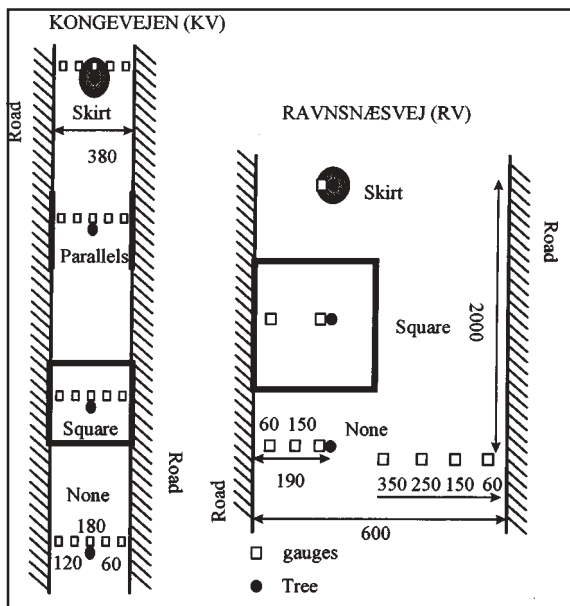
Figure 1. Experimental area at the median strips at Ravnsnæsvej (RV) and Kongevejen (KV), Copenhagen, Denmark. At RV, only one of the tree groups is shown.

The trees at KV were generally unhealthy, suffering from premature autumn coloring and twig and limb dieback, and most trees showed a characteristic witch's broom structure. At this site, three types of straw mat configurations were compared to a control (Figure 1). Besides the box or square and the skirt protective measures, an arrangement of parallel straw mats (parallels) was included. Except for the mats transversing the strip (connecting the mats run-

ning parallel along the roadsides), this setup was identical to that of the square. All sides of the square as well as of the parallel were 3.8 m (12.5 ft) long. The skirt had the same dimensions as on RV.

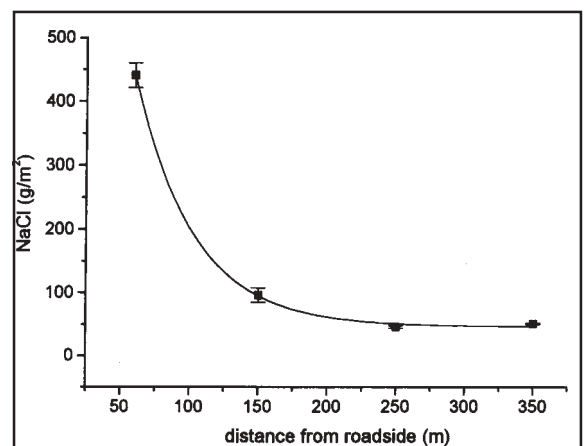
Figure 2. Deposition of road salt (NaCl) at different roadside distances at the median strip at RV. Error bars are calculated as standard errors ( $n = 3$ ). The presented curve is the best first-order exponential fit.

The salt deposition in the two years was comparable in magnitude, although the distribution varied with the largest amount deposited in February 1997 and 1998 and in March 1998 and 1999. Figure 2 illustrates the average yearly deposition at RV at different roadside distances. The mean deposition in the two years was  $441 \text{ g}/\text{m}^2$  at 0.6 m (2 ft),  $96 \text{ g}/\text{m}^2$  at 1.5 m (5 ft),  $46 \text{ g}/\text{m}^2$  at 2.5 m (8.2 ft), and  $51 \text{ g}/\text{m}^2$  at 3.5 m (11.5 ft). Beyond 2 m (6.6 ft), no significant change in the salt load could be observed. The slightly larger deposition at 3.5 m compared to that at 2.5 m could probably be explained by additional deposition from the opposite roadside (distance approximately 2.5 m). The largest deposition definitely occurred close to the roadside and seemed to decline exponentially toward the middle of the median strip.

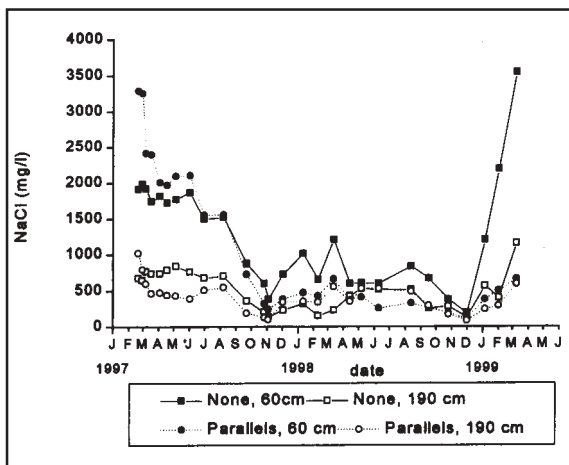
Figure 3. Concentration of NaCl in the soil water at the median strip at KV. Concentraions are given for distances of 60 an 190 cm (24 and 75 in.) from the roadside without protective measures as well as with a protection measure of parallel straw mats.

During the study period, soil water salt concentrations were high, between 20 and 100 times as high as under forest conditions in Denmark (Pedersen 1993; Pedersen and Bille-Hansen 1995). Even though the concentrations peaked in the salt application period during winter dormancy (Figure 3 and Figure 4), the concentrations remained high during the period of growth (Table 3). Despite abundant precipitation (200 to 300 mm [7.9 to 11.8 in.]), there was a tendency to only insignificantly decrease concentrations during spring followed by increasing concentrations during the summer and a pronounced decrease in the late autumn.

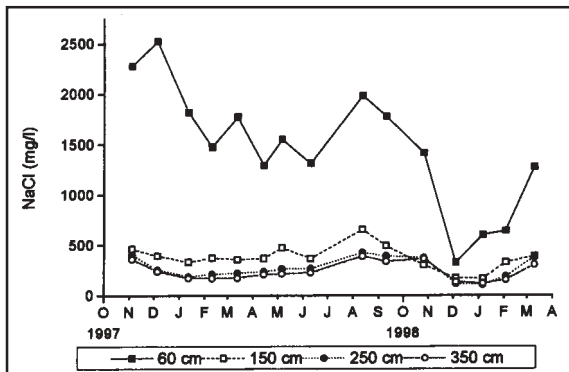
Figure 4. Concentration of NaCl in the soil water at different distances at RV (without protective measures).

NaCl concentrations in the soil water mirrored the deposition figures. Very high concentrations occurred close to roadside. The average NaCl concentrations for the whole study period were 1,595 mg/L at 0.6 m (2 ft), 384 mg/L at 1.5 m (5 ft), 248 mg/L at 2.5 m (8.2 ft), and 235 mg/L at 3.5 m (11.5 ft) from the roadside. As with deposition, the soil water concentrations seemed to decline exponentially toward the middle of the median strip, with only insignificant changes beyond 2 m (6.6 ft).
